VISUAL SITE INSPECTION REPORT – 2019

HOOSIER ENERGY
RURAL ELECTRIC COOPERATIVE, INC.
MEROM GENERATING STATION
AREA 3 RESTRICTED WASTE LANDFILL
MEROM, INDIANA

ATC PROJECT NO. 170LF00788

December 16, 2019

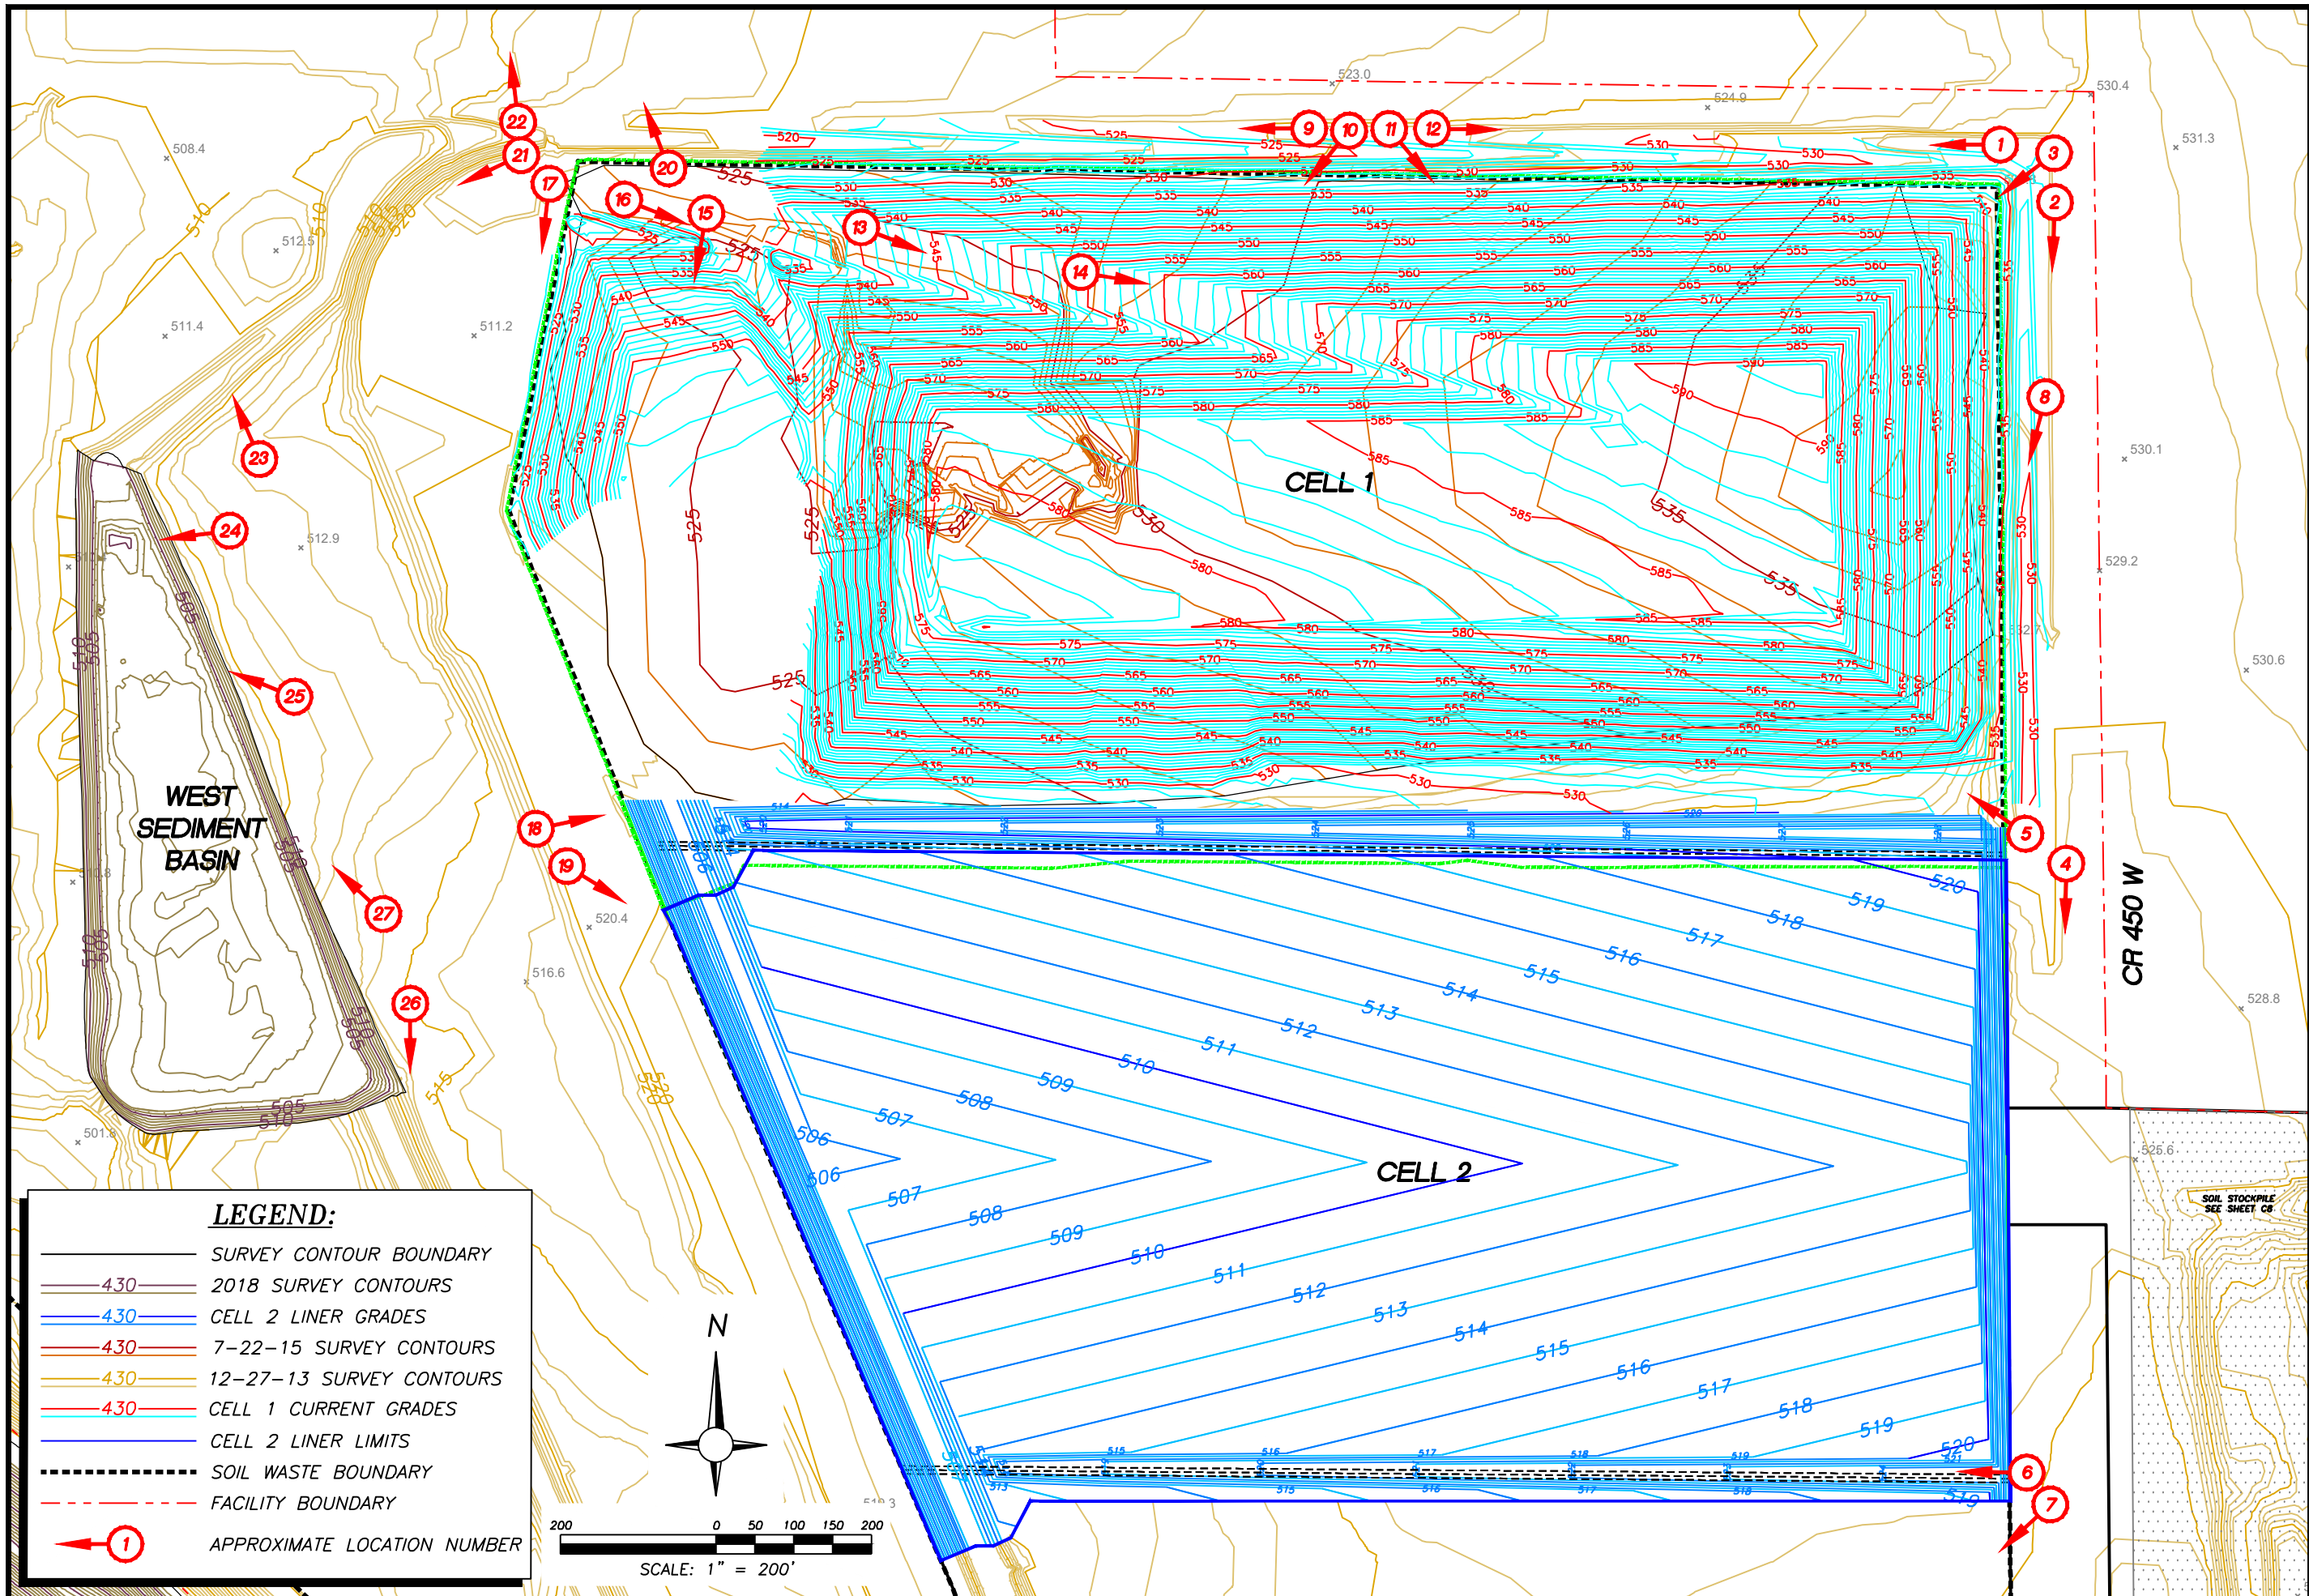
Drn. By:	JG	Ckd. By:	MT	App'd By:	DS	Ckd. Date:	12/2019
Project Number:	17OLF00629	Drawing File:	SEE LOWER LEFT				
OBSERVATION LOCATION PLAN AREA 3 RESTRICTED WASTE LANDFILL 2019 INSPECTION HOOSIER ENERGY MEROM GENERATING STATION							
Date: 12/19 Scale: AS SHOWN Figure: 2

- 6) As noted at Location 8 on the east side of Cell 1 the inspection identified erosion at the toe of the slope above the perimeter ditch.

- 7) At Locations 13 and 14 on the north side of Cell 1 the inspection noted erosion along the road to the top of Cell 1.

- 8) At Location 15 at the northwest corner of Cell 1 the inspection noted erosion from the road into the drainage channel.

- 9) At Location 16 at the northwest corner of Cell 1 the inspection noted that erosion in the road into the drainage channel.

- 11) At Location 18 near the northwest corner of Cell 2 the inspection noted a patch of bare soil above a drainage culvert that could be susceptible to erosion.

- 2) At Locations 21 and 22 in the stormwater channel northwest of Cell 1 the inspection noted erosion at the edge of the riprap.

- 3) At Location 23 in the stormwater channel west of Cell 1, the inspection noted heavy equipment damage adjacent to the riprap lined channel.

- 4) At Location 24 and 25 on the east slope of the West Sediment Basin west of Cell 1 the inspection noted erosion at the crest of the pond.

- 5) At Location 26 on the east slope of the West Sediment Basin west of Cell 1 the inspection noted sediment deposition in the southeast corner of the pond at the inlet of the concrete channel.

Recommendation: Fill the erosion rill and reseed as needed to prevent further erosion.

Recommendation: Fill the erosion and reseed as needed to prevent further erosion. Consider adding more berms to direct stormwater into the drainage ditch.

Recommendation: Fill the erosion and add armoring to prevent further erosion.

Recommendation: Reseed the area as needed to establish vegetation.

Recommendation: Repair the erosion damage and utilize appropriately sized riprap for the expected stormwater flows.

Recommendation: Reseed the area as necessary to reestablish vegetation.

Recommendation: Regrade the area as necessary to restore the drainage into the pond and reseed to reestablish vegetation.

Recommendation: Remove sediment deposits from the channel and the pond on a regular basis.
